# NEW MCEWEN HIGH SCHOOL UPDATE

## NEW 9-12 BUILDING UPDATES

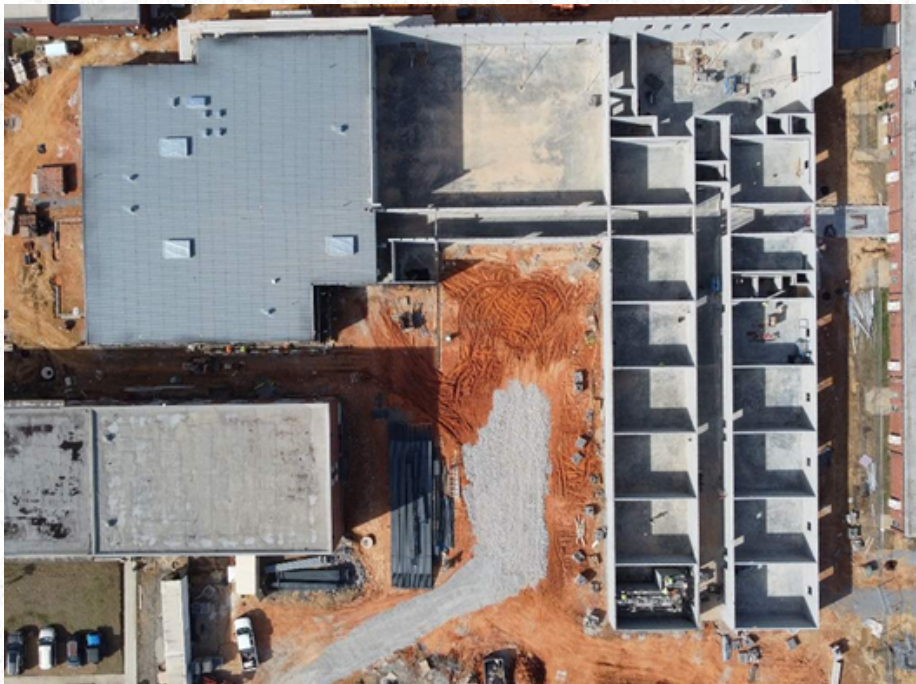
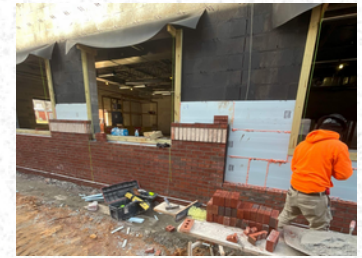
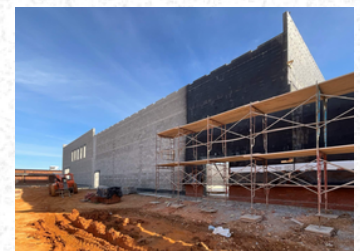
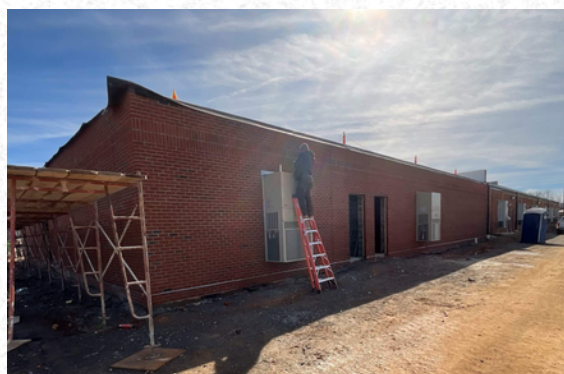
- Black waterproof membrane applied to wall on one-story portion of building and a portion of the gym walls.
- Brick being set and tied into walls with brick ties.
- Header construction in progress in preparation for placement of second floor concrete floor panels. Temporary supports to be removed upon completion.
- Plumbing, electrical, and mechanical line installation in progress around entire first floor. Plumbing lines in place for SPED toilet and laundry and incorporated into interior vertical walls.
